This rare 1940 Cadillac V-16 Model 9033 Imperial Sedan is transformed from a neglected desert dweller into a graceful show winter

Restoration Profile

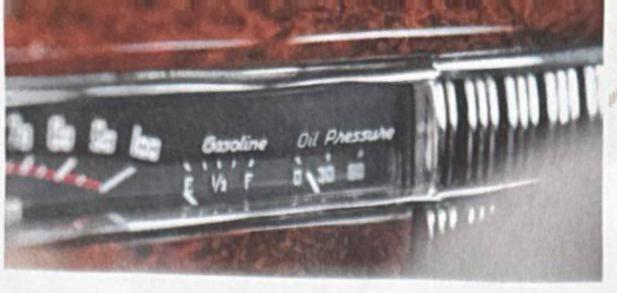
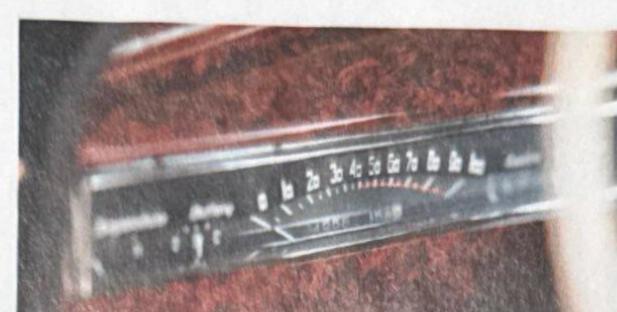
Ken's first view of the 1940 Cadillac V-16 Imperial sedan as seen in the two images above. It was parked under a Tucson, Arizona, carport and partially disassembled, its paint badly sunbaked and covered in desert dust.

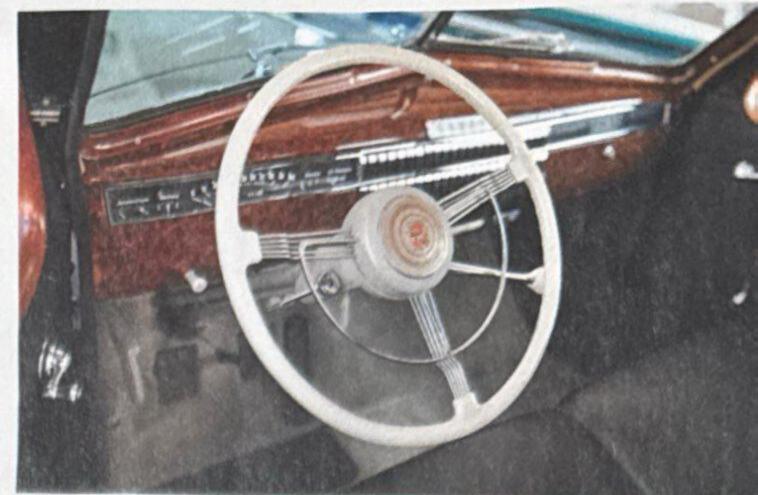
The business of driving the V-16 Imperial sedan was done in Cadillac's traditional luxurious cabin, featuring elegant simulated woodgrain trim and sophisticated instrumentation, though the split front seats were upholstered in durable leather.

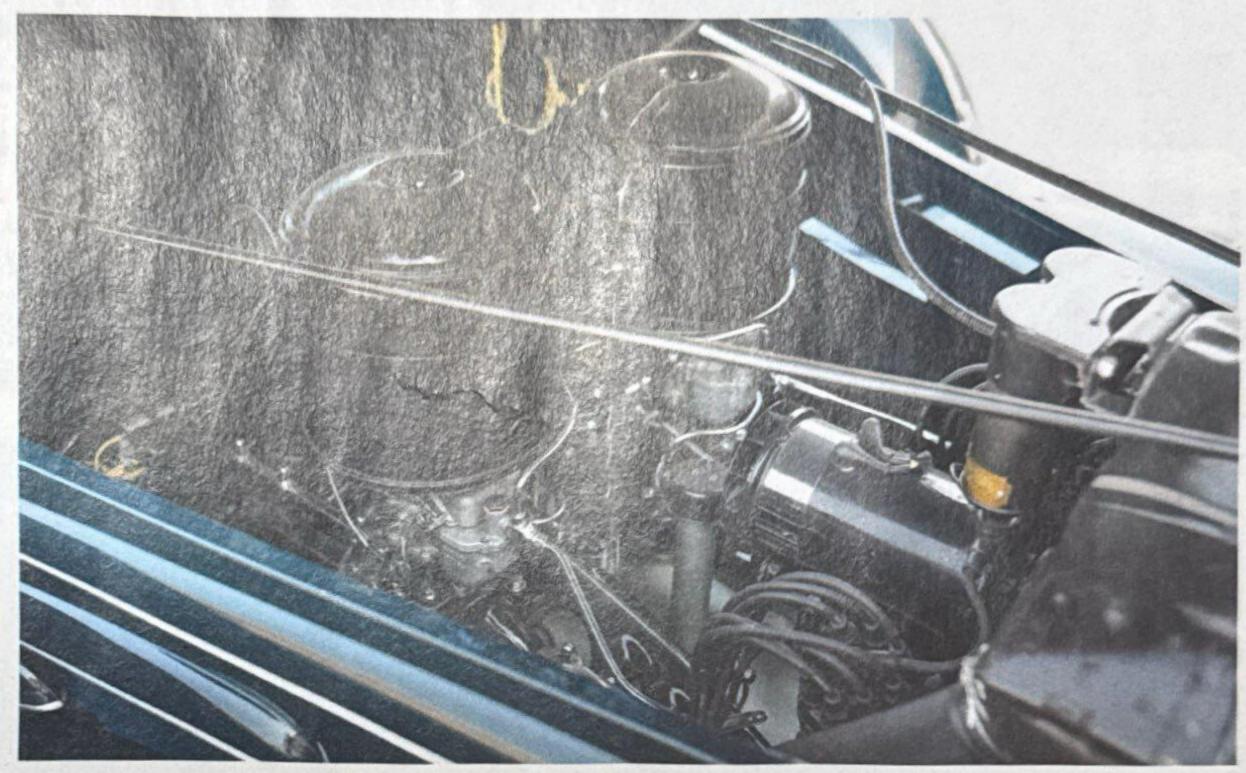
Cadillac's V-16 engine was a 135-degree L-head design that boasted 431 cubic inches of displacement and 185 hp. The overall design was both shorter and 250 pounds lighter than the division's previous 90-degree V-16. Each bank of eight cylinders required its own Carter carburetor and distributor.

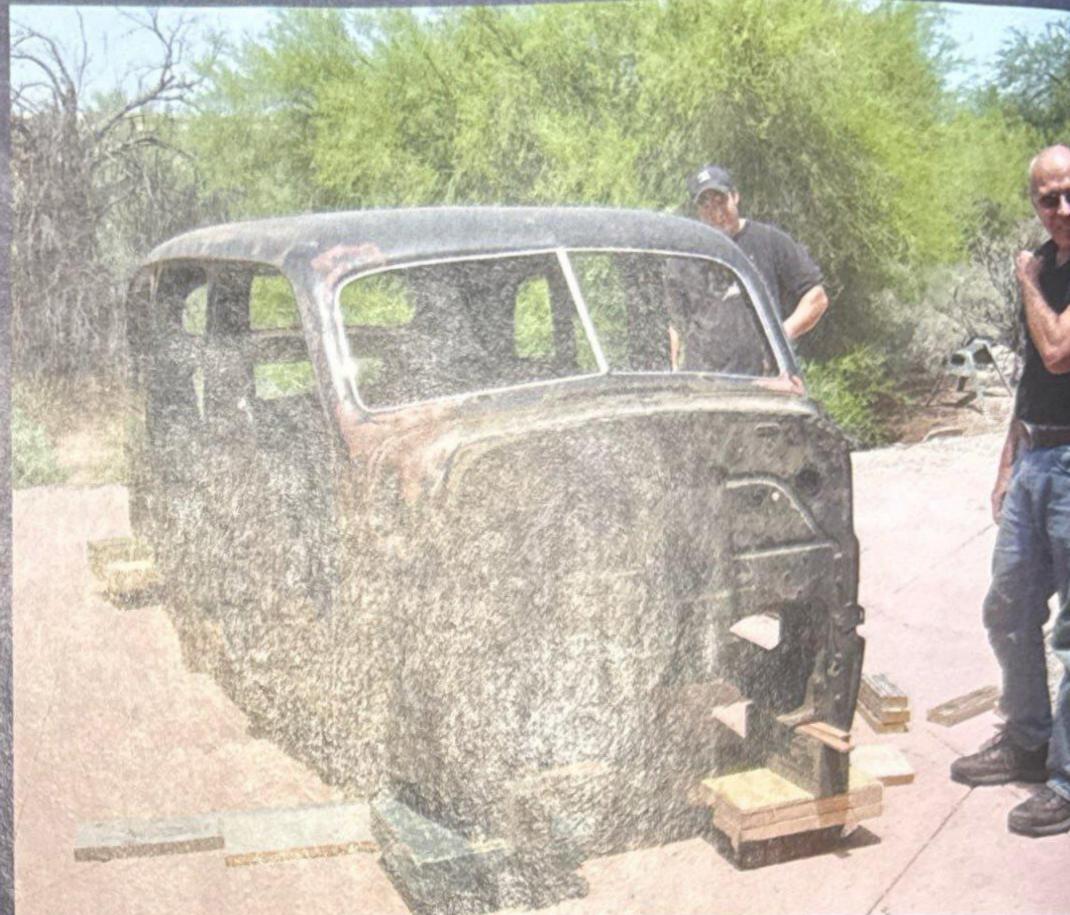
With the help of friends and fellow Classic Car Club of America members, Ken was able to separate the Cadillac's body from the chassis.

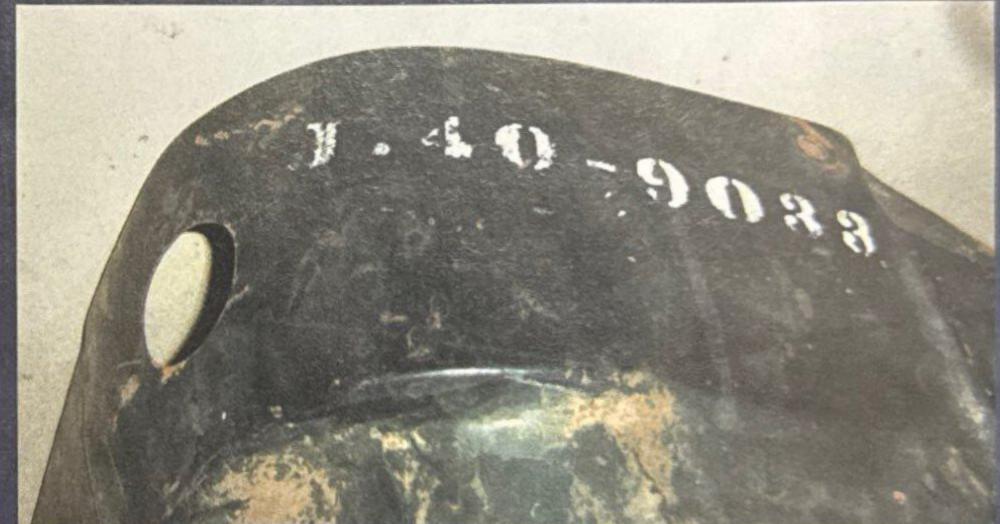
During disassembly, Ken uncovered a factory ink stamping, "40-9033," that further confirmed the Cadillac as being a 1940 model 9033.

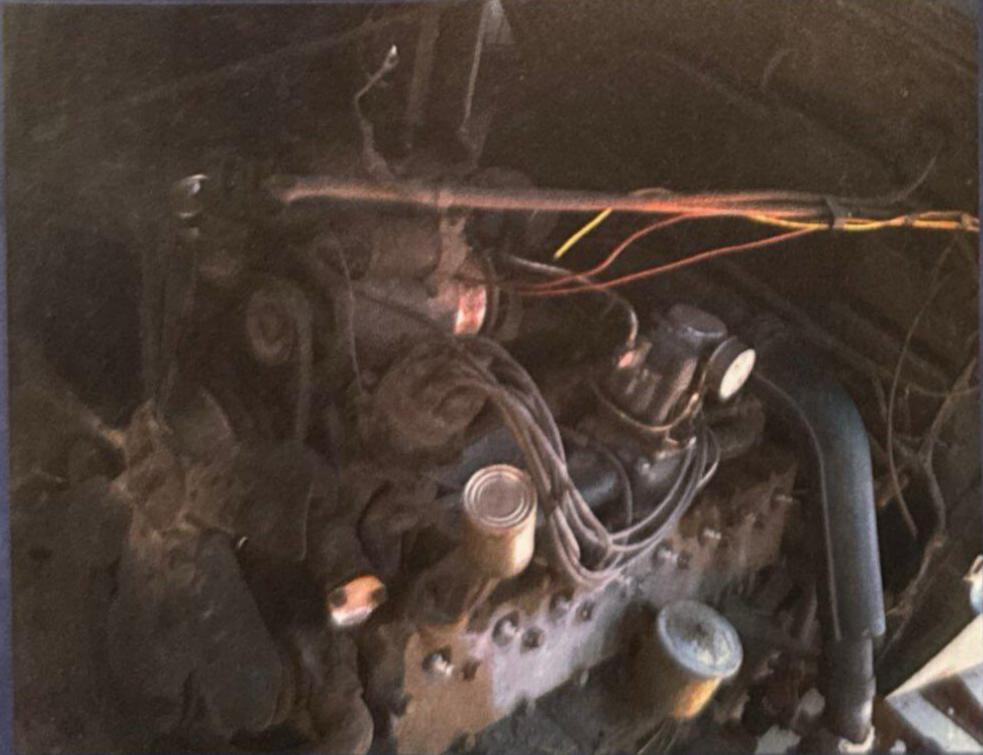
The legendary V-16 engine appeared as though it had not run in years. Note that the spark plug wires are not connected to the plugs and tin foil prevents contaminants from entering the carburetors.

engine was all but clogged with decades of sludge. Fortunately, no damage was found; the engine was merely cleaned, reassembled, and later detailed. Simultaneously, the chassis, most of the suspension system, and differential were media blasted and powdercoated.

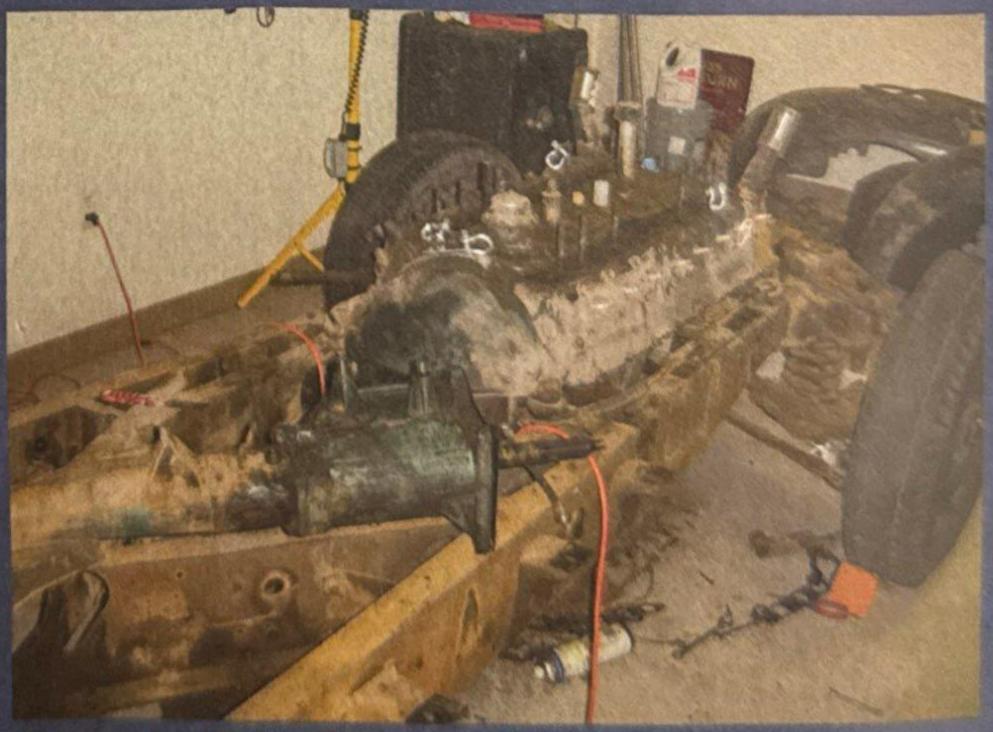
Afterwards, the chassis was rolled into Ken's garage, where he could begin its total disassembly. Here, the three-speed manual transmission has just been separated from the V-16 engine.

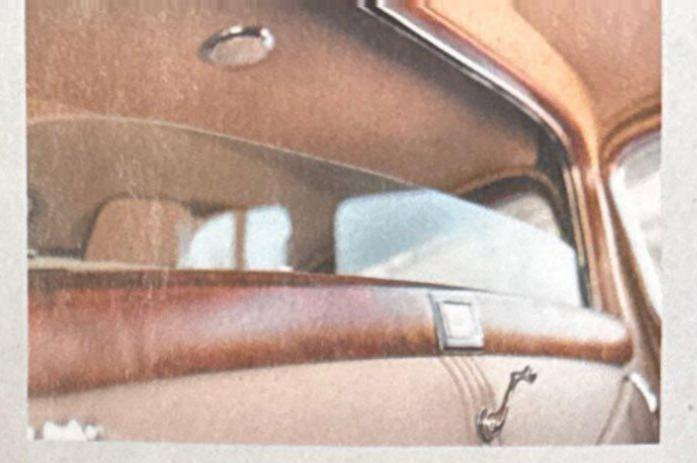
Separating the driver from passengers is a single-pane roll-up window that provided superior conversation privacy.

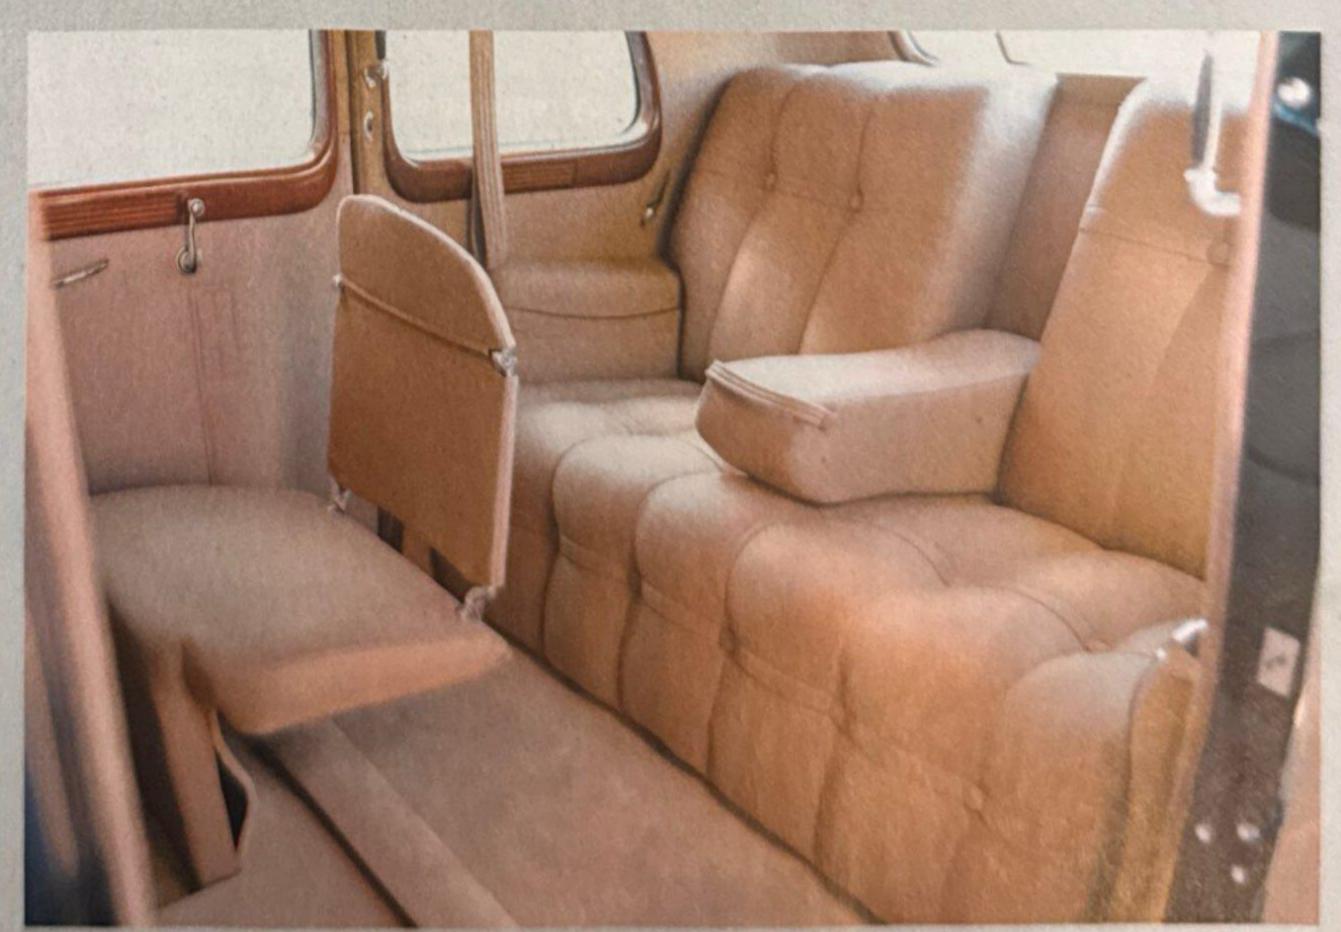
Cadillac's V-16 Imperial Sedan is listed as a seven-passenger vehicle, made possible through the provision of two collapsible jump seats, which themselves are finished as elegantly as the rest of the rear passenger compartment.

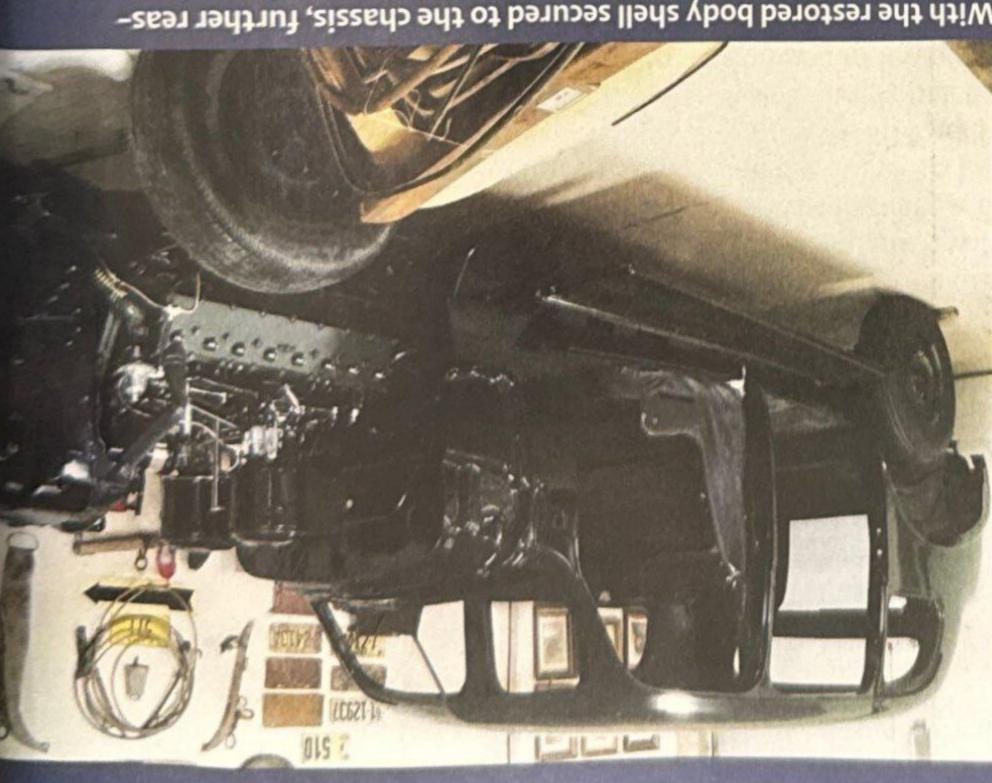
been fitted, as have the running boards. sembly can begin in earnest. Note that the front seat frame has With the restored body shell secured to the chassis, further reas-

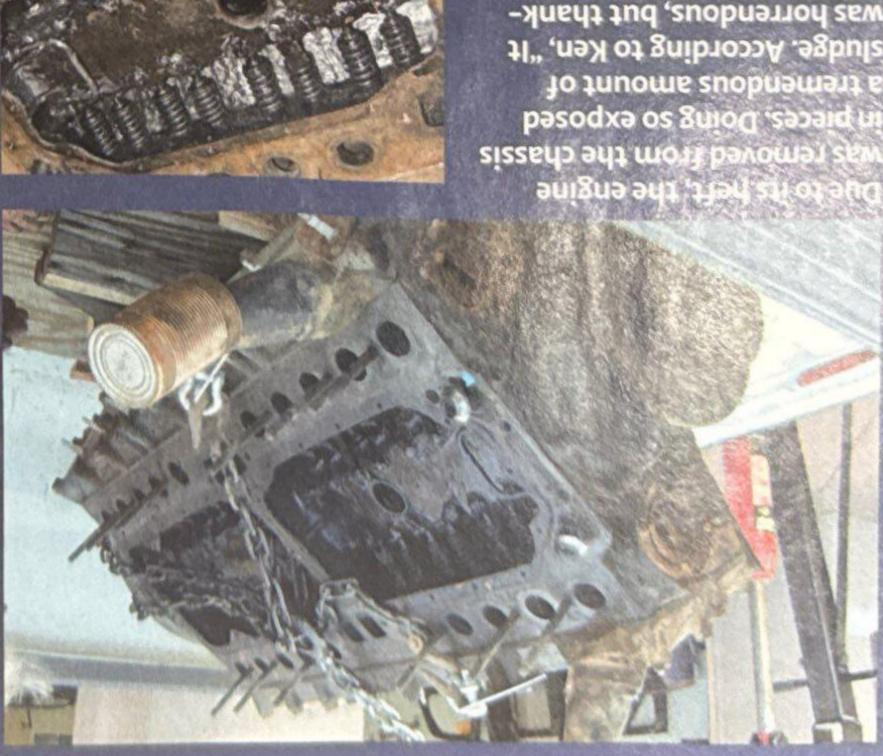
cleaned and reassembled." aged. The engine was merely components were damfully none of the internal was horrendous, but thanksludge. According to Ken, "It

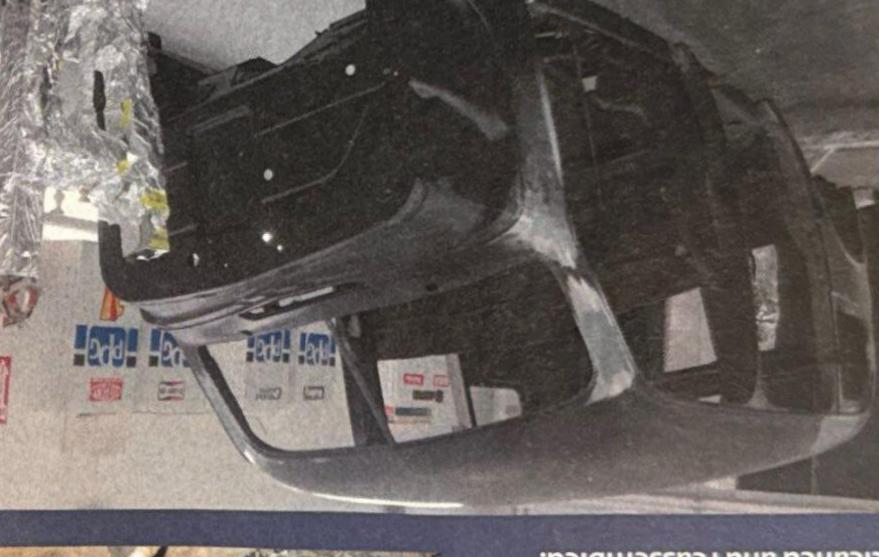
and paint stages. already completed and the shell was being prepared for primer Meanwhile, minimal fabrication work that the body required was

"There were only two areas of real concern: One of the front door posts had a bit of rot in the metal that would require some fabrication work, and it looked like someone had taken a sledgehammer to the trunk lid. I'm not proficient in bodywork, so I sent the shell and all the removed panels to the same shop that did the Auburn. They do nice work, and I thought if all they had to focus on was the body, then I could work on other components simultaneously," Ken says.

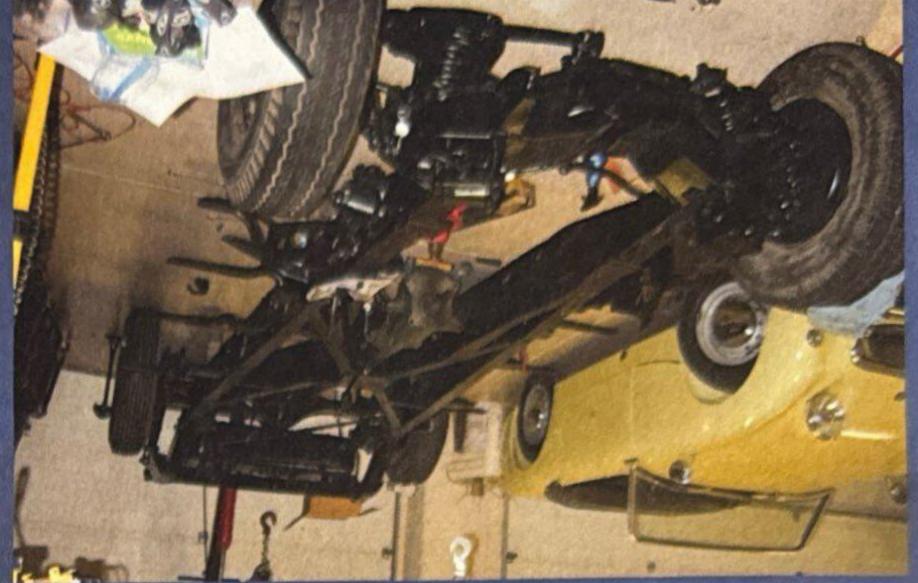
will spot the transmission held in place temporarily. of the restored suspension system had been installed. A keen eye By November 2011, the frame had already been painted and much
